Background

The New/Modified Rule:

LAKE SPEED TRIALS
RULES and RECORDS

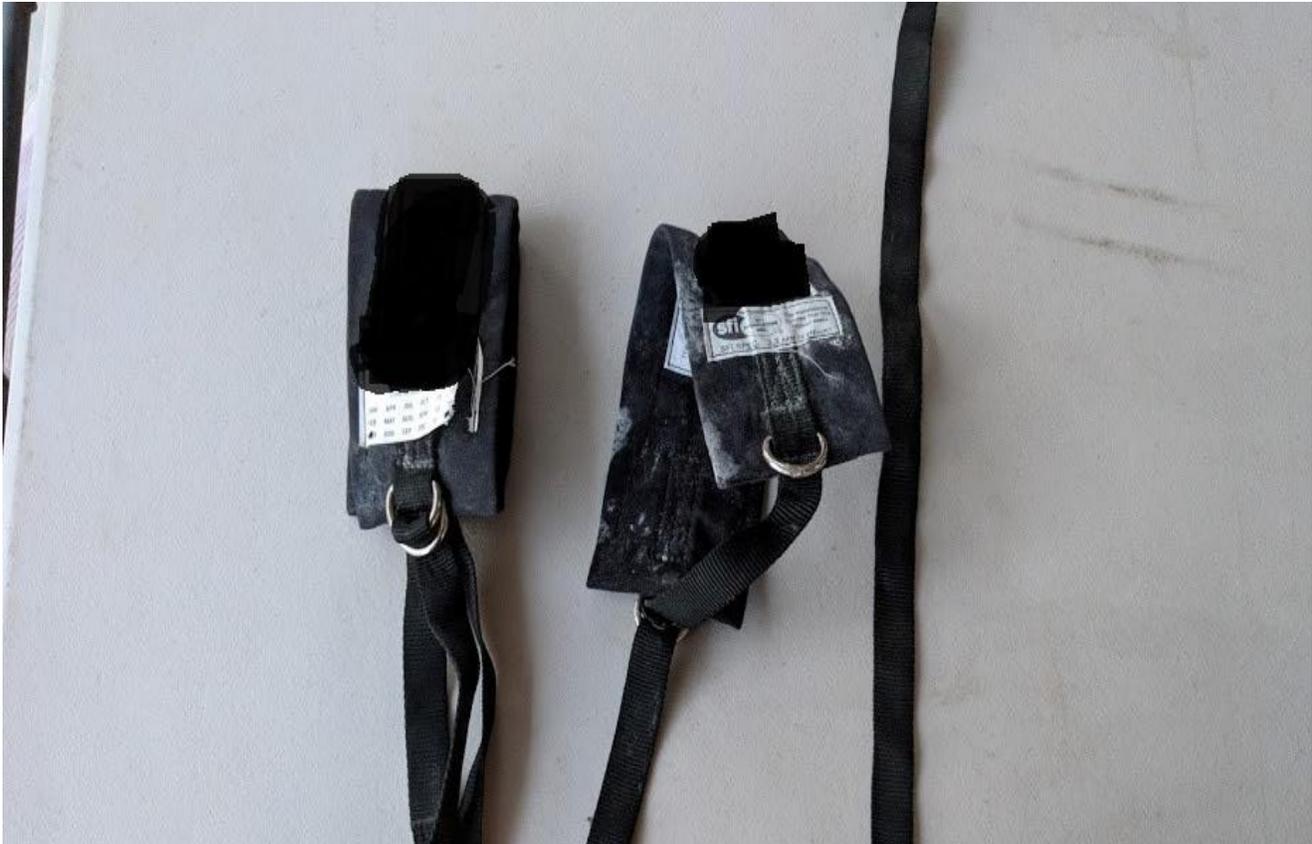
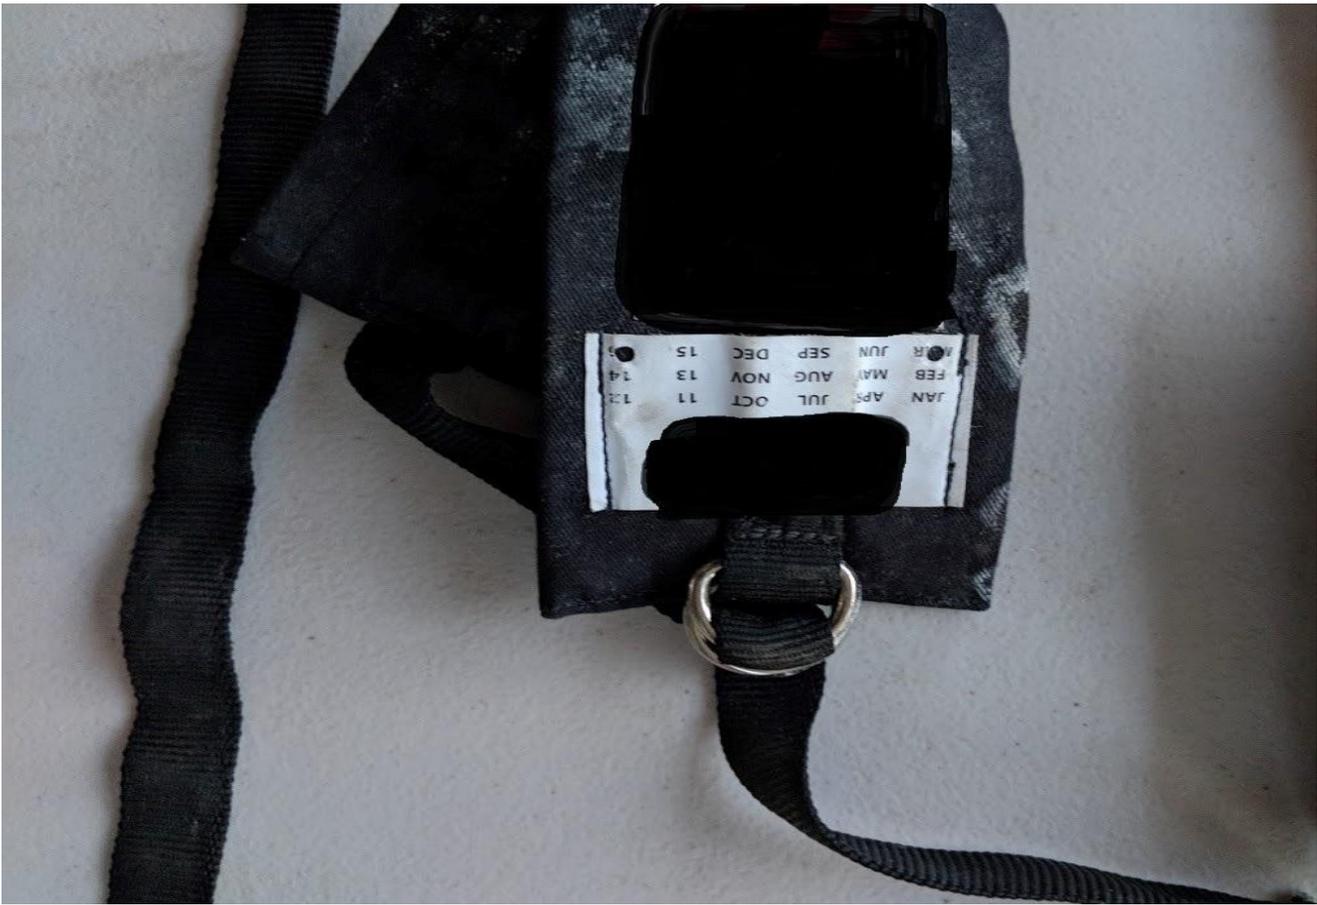
Below are some photographic examples of both acceptable and un-acceptable arm restraints. These are photos of the latest "Failures"... again not manufacture specific... type specific...

1. The first being a mechanical failure of the "welded" "D" ring(s) when being used as an adjuster in the restraint. Our solution for this failure is to disallow the use of Welded or non-one-piece D rings unless they are being used as an attachment ONLY point. Please note that we have not observed failures in the D rings (two) when they are being used only as an attachment ONLY point. An example would be the sewn-in D rings in a fire suit that are being used ONLY as an attachment point.

2. The second common failure with the D rings is they are "un-adjusting" during multiple impacts. The solution is to eliminate the D rings when being used as an adjuster and replace with a Three Bar adjuster. I.E. the elimination of D rings for any adjuster application.

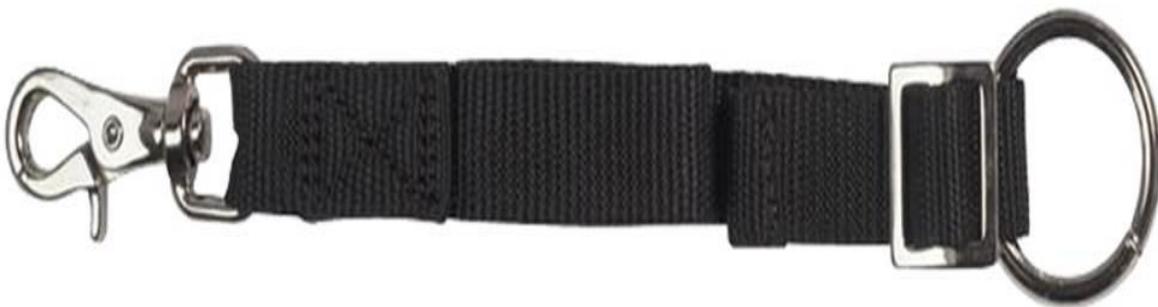
This type of arm restraint has a single welded ring for belt attachment (not adjusting) with 3 bar length adjuster the attachment at the cuff is a multi-piece swiveling “quick connect” that’s held together with a single rivet ... this meets the letter of the new rule and conversations with SFI about test results were positive

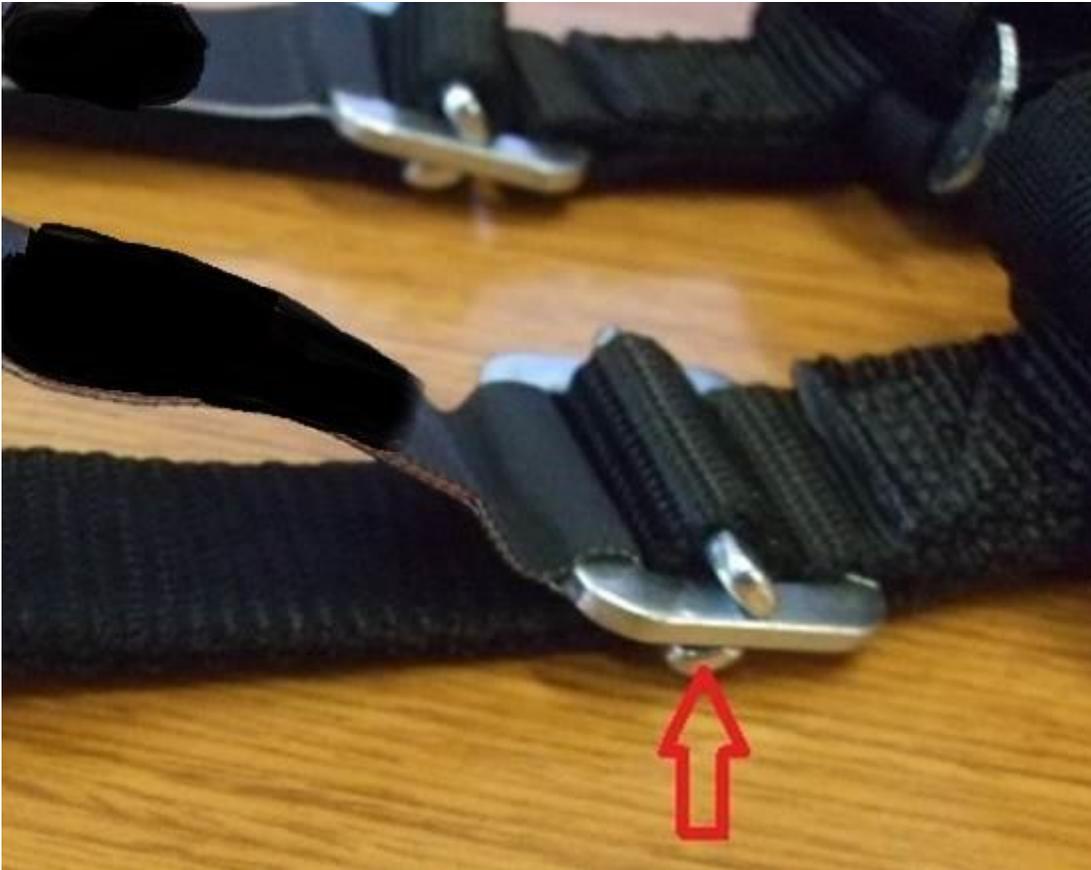
Another example of a “compliant” arm restraint – has outer square ring with sliding adjustment bar – no D rings present
